Unity Pond Watershed Survey

Final Report

October 25, 2021

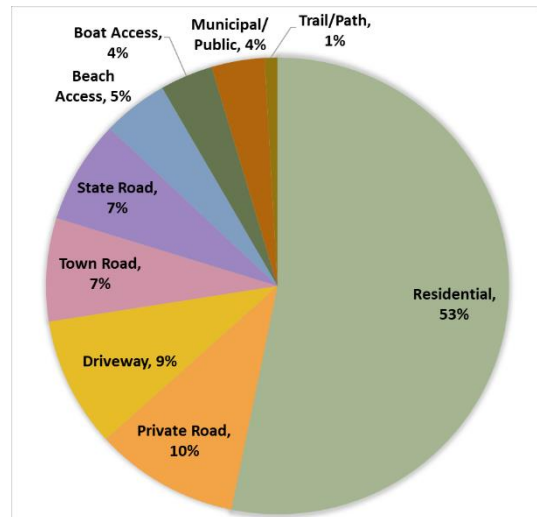
Figure 2. Percentage of sites in each land use category.

A total of 109 sites were identified across 9 different land uses. The majority of sites were on residential properties. This land use accounted for over half of all sites documented. Private roads, driveways, and town/state roads were the next most common locations (Figure 2).

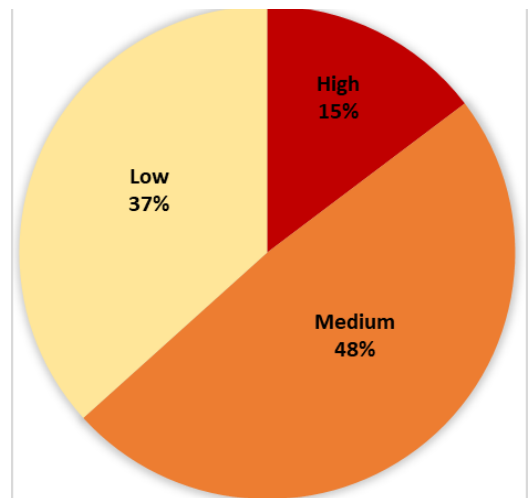
Figure 3. Percentage of sites in each impact rating category.

Of the 109 sites documented, 16 sites, or 14.7% of the total, were considered a high impact to the lake. Most of these were located on the western shore of the pond. These were primarily residential (9 sites), but also included 3 road sites, 3 municipal/public sites, and one boat access site. Medium impact sites accounted for 48.6% of all sites and the remaining 36.7% of sites were considered low impact (Figure 3).

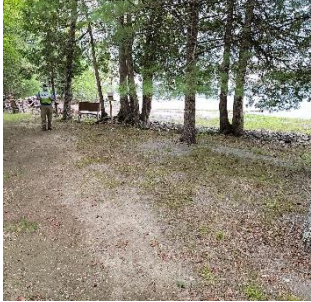
Land Use	Common Issues	Recommendations	Photo
Residential	Surface Erosion	Runoff Diverters, Erosion Control Mulch

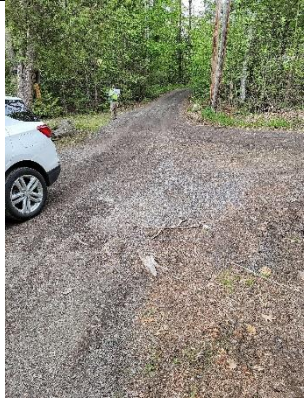
Bare Soil	Limit Raking, Reseed Lawn, Erosion Control Mulch	
	Lack of Vegetation	Plant Buffer or Rain Garden	
	Roof Runoff Erosion	Infiltration Trench	
	Unstable Paths/Lake Access	Infiltration Steps, Crushed Stone, Runoff Diverters	
	Shoreline Erosion	Add Vegetation	
Private Road/Driveway	Surface Erosion	Crown, Add Gravel, Add Recycled Asphalt, Pave

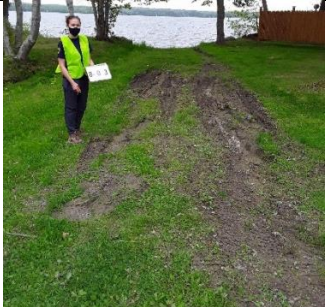
Beach/Boat Access, Trails & Paths, Municipal	Surface Erosion	Add Crushed Stone, Runoff Diverters

Bare Soil	Erosion Control Mulch, Crushed Stone	
	Unstable Shoreline Access	Add Vegetation, Add Pavers, Add Crushed Stone	
	Shoreline Erosion	Add Vegetation

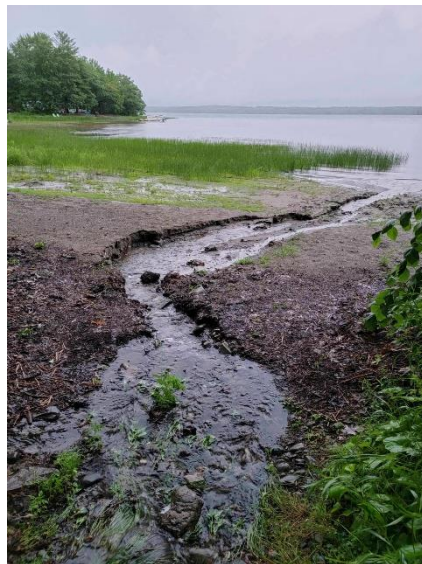
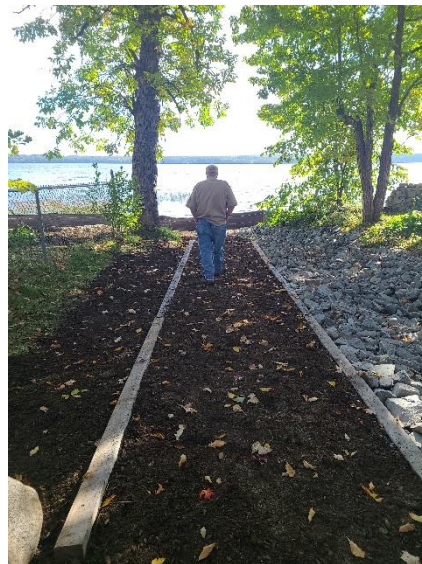
The impact of NPS pollution on Unity Pond can be reduced through the combined effort of FOLW, WCSWCD, watershed towns, road associations, and watershed residents. Through a combination of grant funding, LakeSmart and Youth Conservation Corps programs, technical assistance, and education and outreach, FOLW hopes to address all of the sites identified in the survey, starting with the highest impact sites. Already, FOLW has worked with the Town of Burnham to address two high impact sites at the town beach (see before and after pictures below).
